Request for Proposals (RFP): Pedestrian Bridge to Orange Line Connection

Organization Name: Upstate Greenways and Trails Alliance

UGATA will plan, design, engineer, and permit a trail connectivity project on the Orange Line of the Prisma Health Swamp Rabbit Trail. This project will be called the **Pedestrian Bridge to Orange Line Connection.** This project will involve retrofitting a disused railroad trestle bridge to allow for bicycle and pedestrian use.

SWAMP RABBIT TRAIL: ORANGE LINE REEDY RIVER BRIDGE FEASIBILITY STUDY

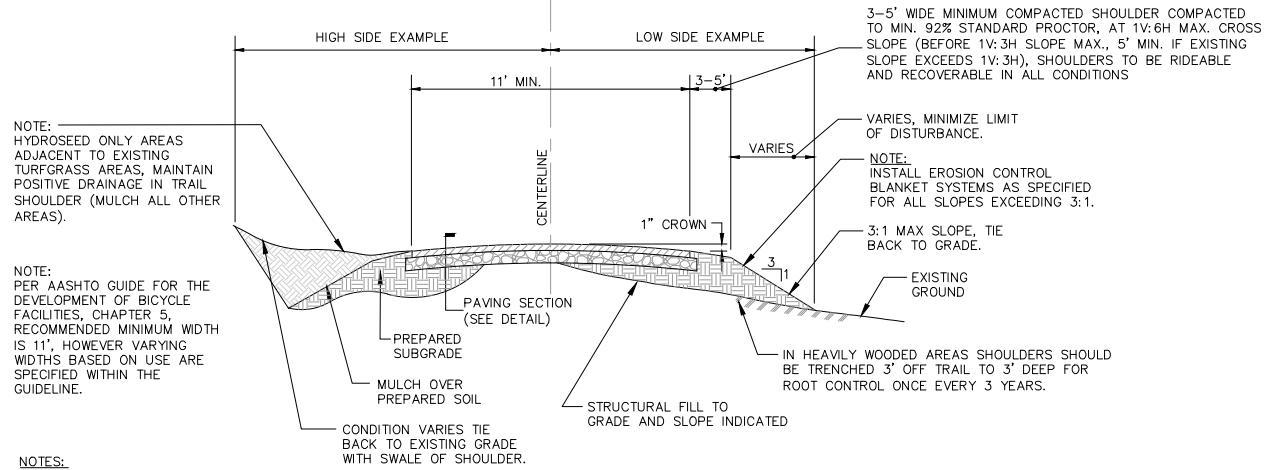
ASPHALT TRAIL SECTION

- MINIMIZE TREE REMOVAL AND DISTURBANCE WHEN CLEARING FOR PATHWAYS.
 PREPARE SOIL TO A DEPTH OF 3", CLEAN AND FREE OF ALL ORGANIC LAYER (LEAVES/DEBRIS REMOVED)
 CROSS SLOPE OF TRAIL NOT TO EXCEED 2%.
 CONTRACTOR TO CONTACT GEOTECHNICAL ENGINEER IF ANY UNSUITABLE SOIL CONDITIONS ARE ENCOUNTERED, WHICH MAY COMPROMISE STRUCTURAL INTEGRITY OF PATH.
 ENSURE TRAIL AND SHOULDERS ARE CLEARED OF ALL TREES AND VEGETATION THAT COULD CAUSE ROOT GROWTH BELOW TRAIL BED.
 4" DASHED OR SOLID CENTERLINE (THERMOPLASTIC OR RETRO REFLECTIVE PAINT DEPENDING ON TRAIL CONDITIONS

- CONDITIONS. C EVERY 1/10 OF A MILE PROVIDE ALPHA NUMERIC MILEAGE SYSTEM W/ 4" NUMBERING (THERMOPLASTIC OR RETRO REFLECTIVE PAINT) AND POSTS EVERY 1/2 MILE THAT ARE 2' MIN. FROM EDGE OF TRAIL.

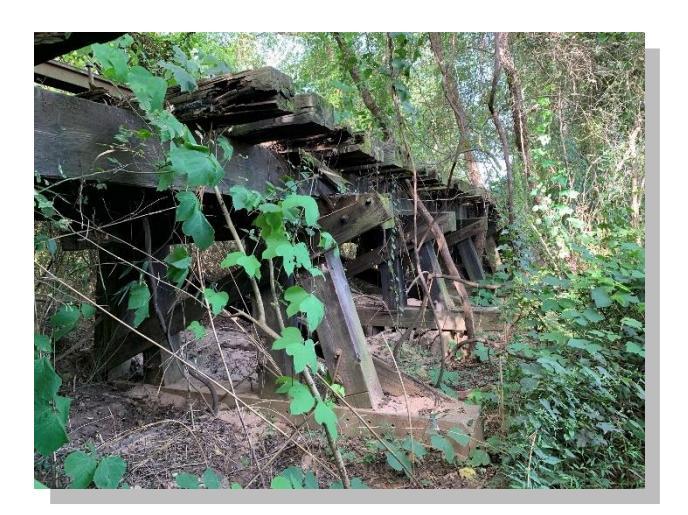
Figure 2: General Deck Condition

The deck was inspected from the ground for signs of deterioration and damage. The railroad ties consistently showed signs of moderate to severe decay (**Figure 2**). The superstructure has two continuous built-up timber stringers. Each stringer has two 8x16s and one 7x16, bolted together in parallel and stagger connected. Both stringers sit directly on top of bent caps. There are no bearings to secure the stringers to the cap and effectively transfer loading to the substructure, other than occasional single short steel dowels. The superstructure slid off the south side of the caps in Spans 1-13, likely due to flooding (**Figure 3**). The stringers have minimal to minor decay, with only isolated areas of severe decay. See **Appendix B** for a plan view of the existing superstructure.

Stringers should be realigned. The railroad ties and steel tracks should be removed and replaced with a corrugated metal deck filled with flowable fill to match similar Swamp Rabbit Trail bridges nearby for ease of maintenance. According to the AASHTO Guide for the Development of Bicycle Facilities, a rail height of 48 inches and a trail width of 11 feet minimum is recommended in locations that are anticipated to serve high user volumes. For pathway widths greater than 10 feet, the LRFD Specifications for the Design of Pedestrian Vehicles specifies an H10 design vehicle loading. The additional loading of this design vehicle would incur a substantial increase in construction costs. Therefore, a clear width of 10 feet is recommended for this location. A typical section of the proposed bridge is shown in **Figure 9**.

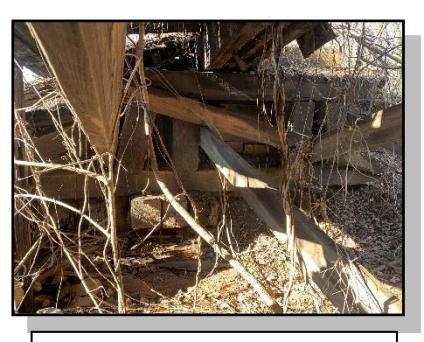
Figure 4: Typical Abutment

The abutments (Bents 1 & 32) are frames made up of timber caps, posts, and mud sills supported by timber piles. A small portion of the abutments were buried and inaccessible for inspection. Both abutments exhibited minor to moderate decay and minor to severe crushing of the cap, in addition to erosion of the surrounding soil (**Figure 4**).

The heavily decayed bents should be removed, and the remaining bents can be reused and restored. The abutments should be replaced with concrete spread footings with riprap armoring on the embankment, properly sloped, to resist erosion and protect the integrity of the structure. The riprap should be extended to adjacent ditches to prevent undermining of the planned asphalt approaches. Repairs should be made to deteriorated timber pile tops and steel piles at the waterline.

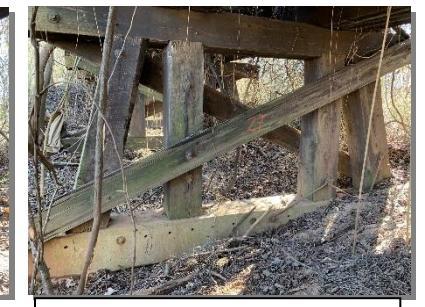
Figure 7: Timber Frame with Concrete Mud Sill

Numerous timber bents exhibited various levels of decay or splitting of the cap, posts, and mud sill, from minor to severe. Many of the timber piles supporting the frames had severe deterioration at the mudline. Most of the diagonal bracing has moderate to severe decay.

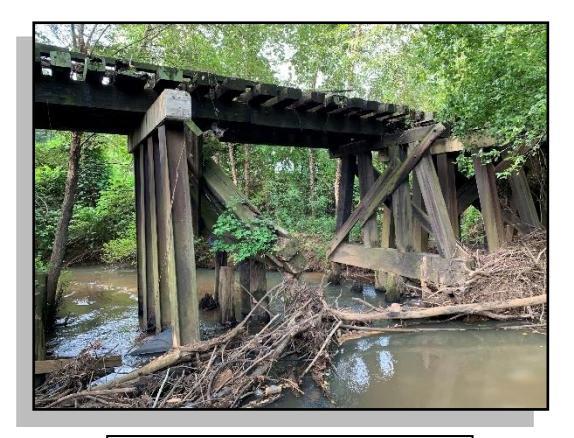
Figure 8: Replacement Bents

There are several bents that have partially or fully collapsed, and it appears that new bents were installed in their place (**Figure 8**). In locations where a portion of the superstructure has slid off the caps, there are several bents that have been moderately forced out of alignment.

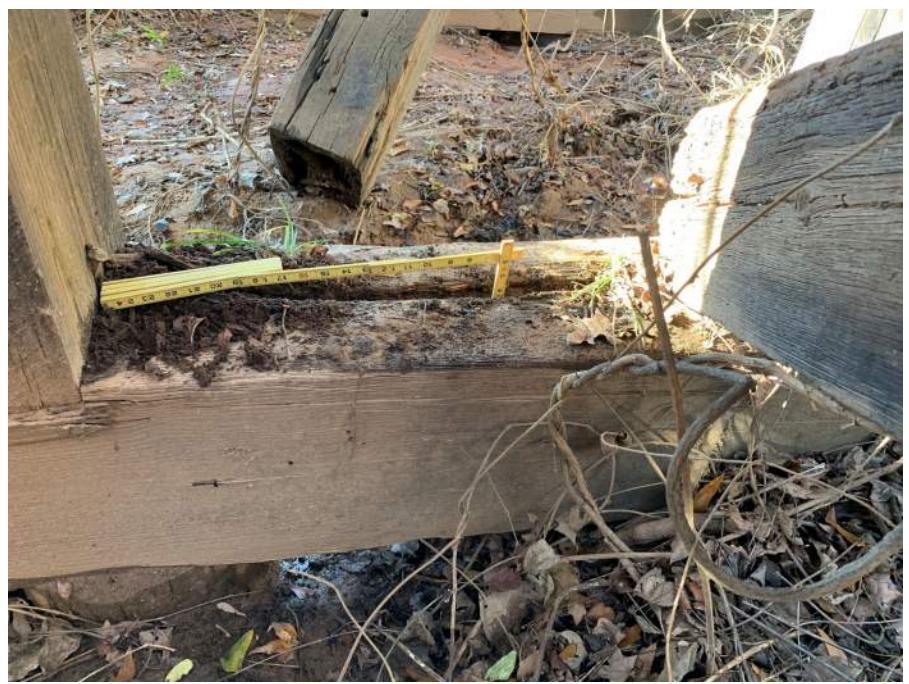
Bent 3: Mud Sill Decay

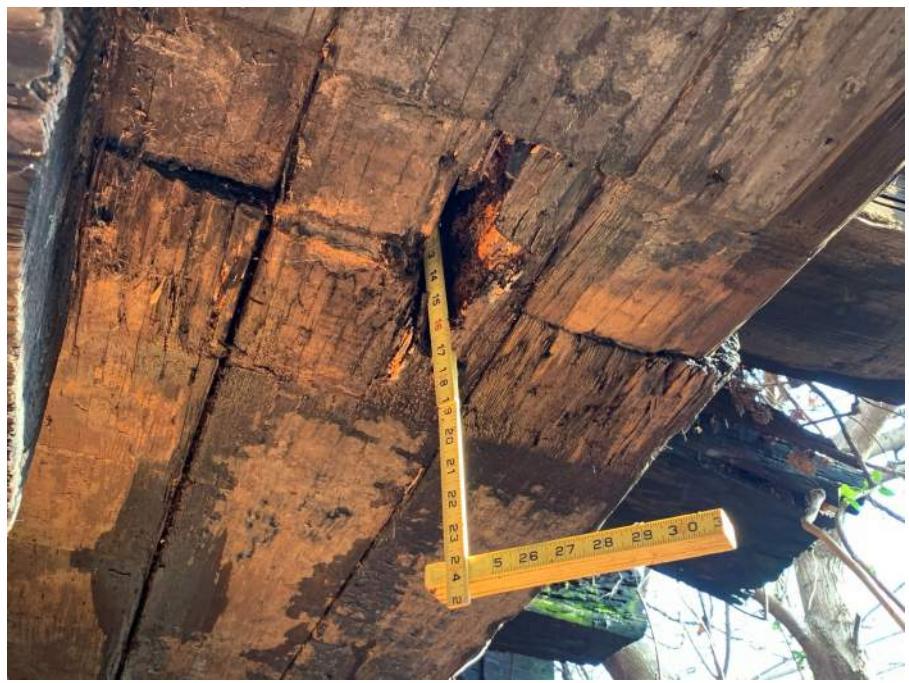
Bent 8 (Stringer Decay)

7	x					x				х			Bent 7 has tilted and has minor decay in the Timber Piles. Piles can be encased in concrete to prevent any further decay. This bent will need to be moved 1 ft to maintain maximum span length of 26 ft.
8		x				x						x	Bent 8 has a minor deficiency in the stringer. There is also minor decay in the Timber Piles that can be encased in concrete to prevent any further decay. Move to Bent 9 position.
9	x		x			x					x		Bent 9 has been tilted out of alignment. Moderate deficiencies in the Cap and Timber Piles. Recommend removal and replacement with Bent 8.
10						х				x			Bent 10 has minor deficiencies in the Timber Piles that can be encased in concrete to prevent any further decay. Move to Bent 11 approximate location, maintaining 26 ft span length.
11	х										х		Bent 11 has fallen over and should be removed. Replace with Bent 10.
12	x		x		x	х						x	Bent 12 is to be moved approximately 3' to control the span length of 25'. Bent 12 will be utilized and repairs will be made as needed to make sure Bent is adequate for carrying loads.

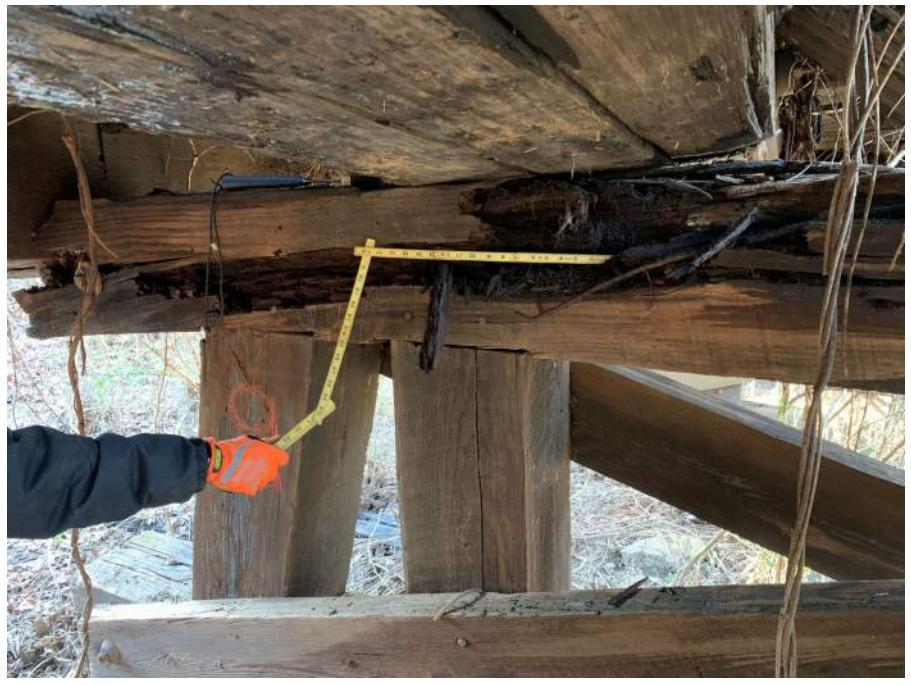
Bent 9 (Cap Decay)

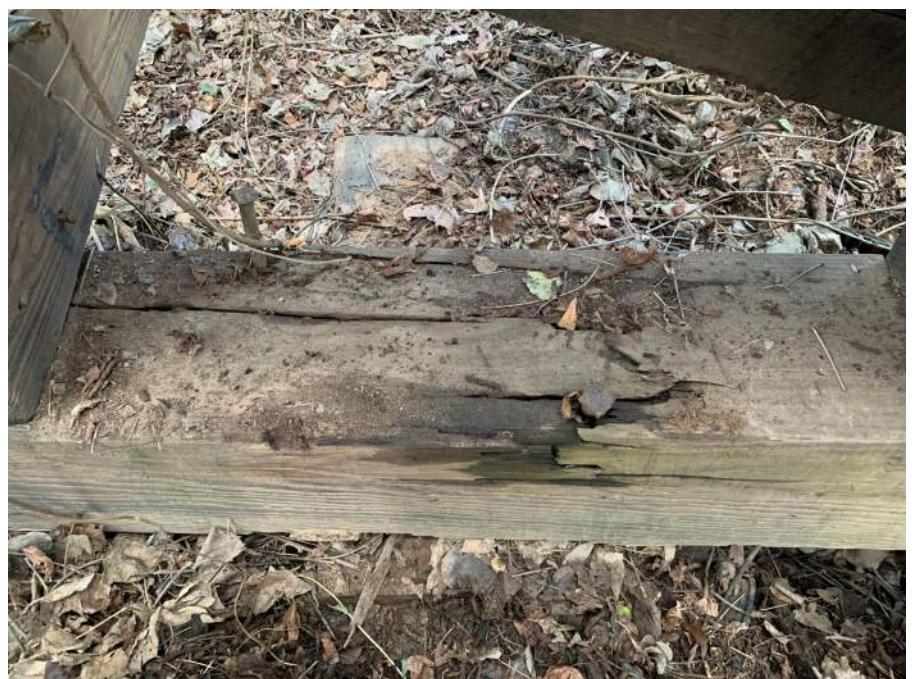
Bent 13 (Mud Sill Decay)

13					x					х			Bent 13 has minor deficiencies in the Timber Frame therefore Bent 13 is a great candidate to stay.
14			x							х			Bent 14 had minor deficiencies discovered in the Cap during the inspection. To keep span lengths from getting too long, keep in place.
15			x								x		Bent 15 had deficiencies discovered in the Cap during the inspection which lead to the conclusion that Bent 15 should be removed.
16										х			Bent 16 is a great candidate to remian with no deficiencies noted.

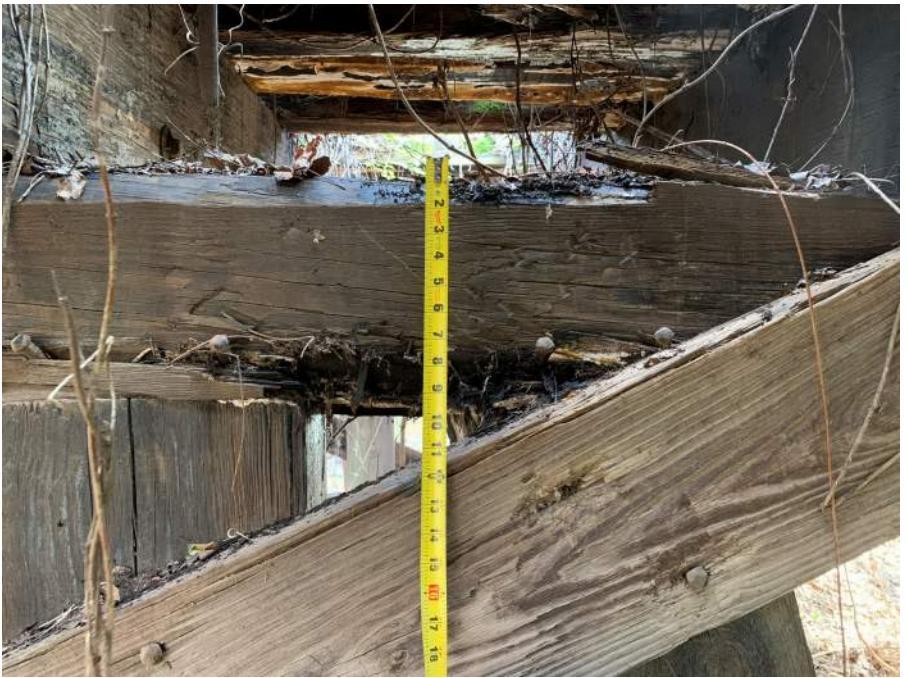
Bent 14 (Cap Decay)

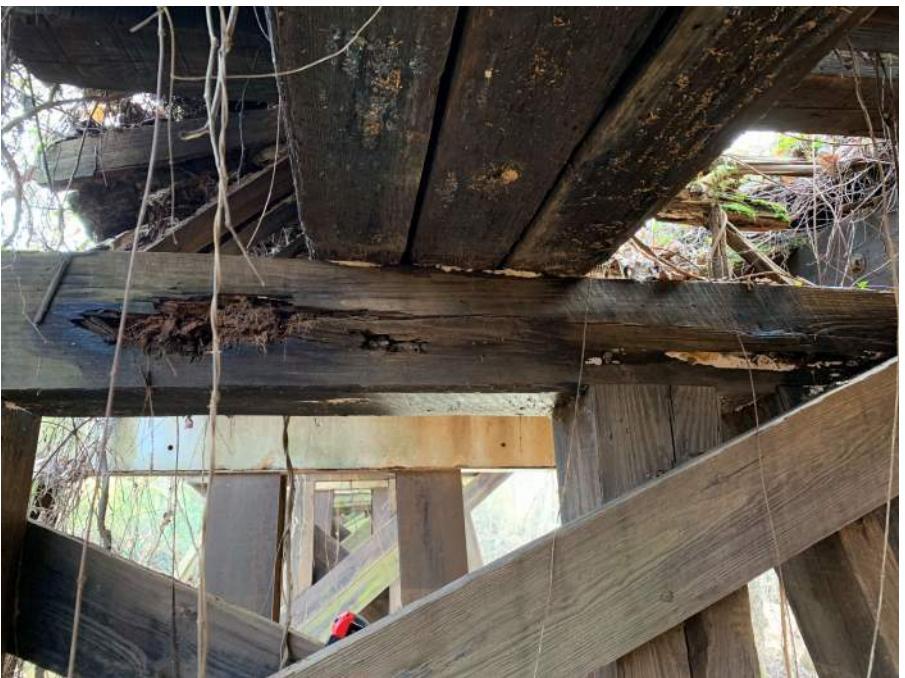
Bent 15 (Cap Decay)

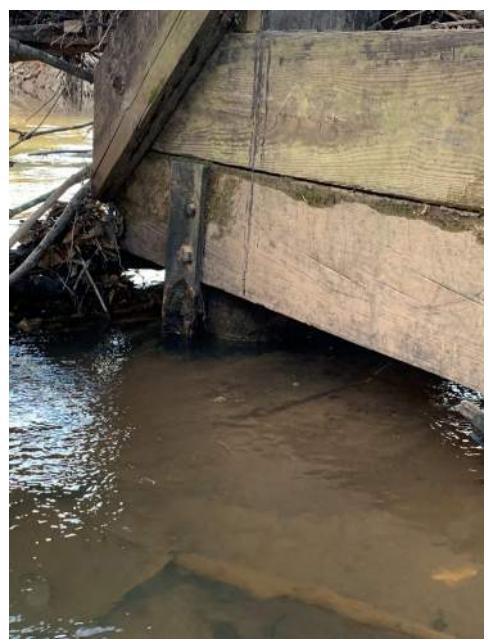
Bent 17-1 (Motor Grader Blade Repair for Timber Piles)

Bent No.		Timber Be	nt Defic	iencies/Decay			Concrete Cap w/ H	-Piles Deficiencies	Replace	Remain	Remove	Move	Recommendations
	Tilted, Torqued, or Fallen	Stringer	Сар	Timber Frame	Mud Sill	Timber Piles	Concrete Cap	Steel H-Pile					
17-1											x		Bent 17-1 is surrounding 17-2 which is a Concrete Cap with Steel H-Piles. It was determined that it was unnecessary to keep this additional Bent.
17-2								x		x			Bent 17-2 is a Concrete Cap with Steel H-Piles. Noted in the inspection report is some section loss and pitting at the mudline of the piles. Repairing these deficiencies is recommended.
17-3										x			Bent 17-3 will remain to be utilized in controlling the span length of 25'.
18	x					х					x		Bent 18 has fallen over and should be removed
19								x		х			Bent 19 is a Concrete Cap with Steel H-Piles. Noted in the inspection report is section loss and pitting at the mudline of the piles. Repairing these deficiencies is recommended.

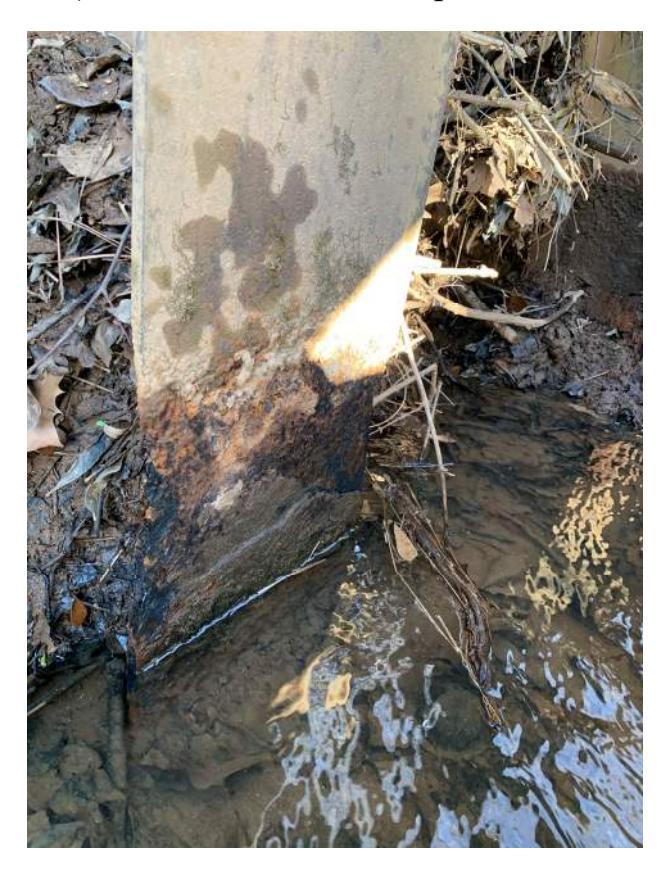
Bent 17-2 (Pile Decay at Mudline)

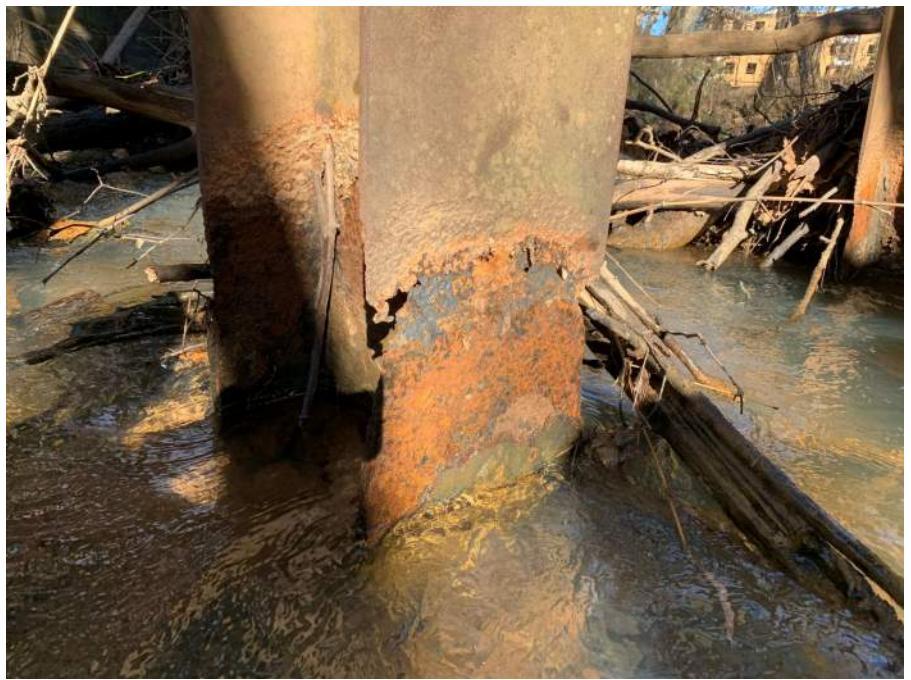
Bent 19 (Pile Deterioration)

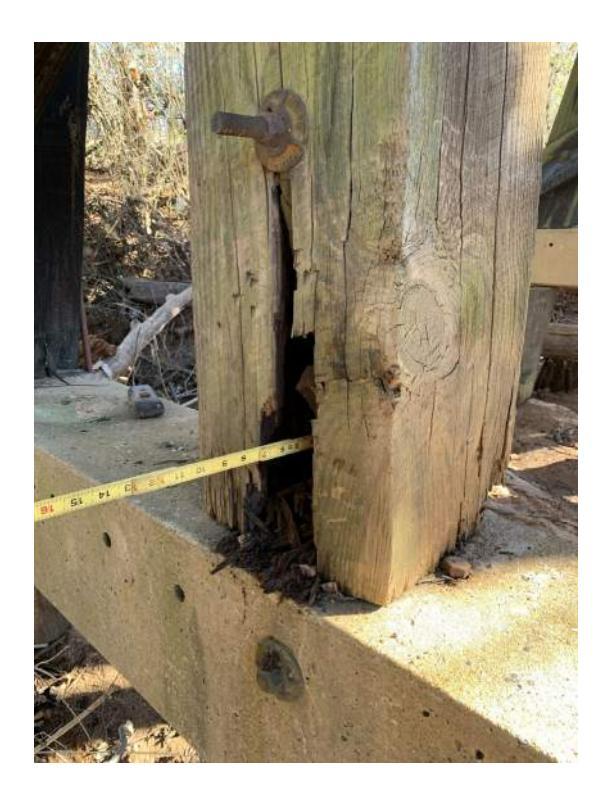
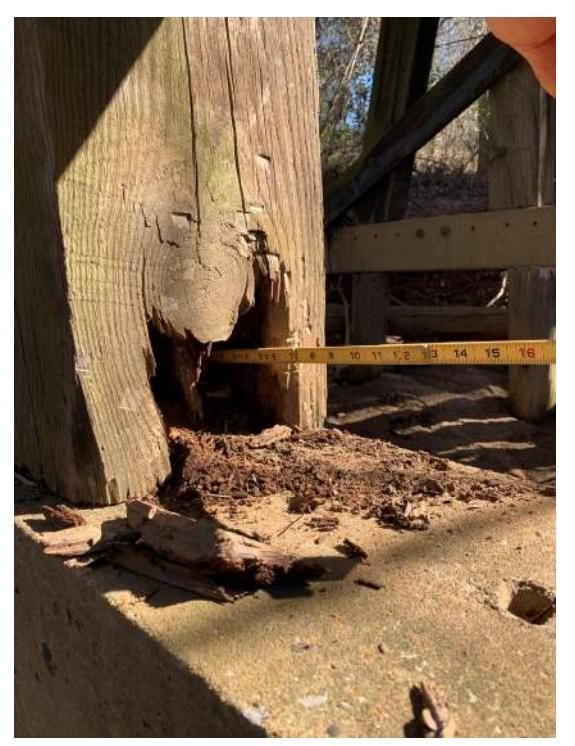
Bent 21 (Timber Frame Decay)

20	х										×		Bent 20 has fallen over and should be removed.
21				x		x					x		Bent 21 had deficiencies discovered in the Timber Frame and Timber Piles during the inspection leading to the conclusion that Bent 21 should be removed to be most cost effective. Move Bent 22 into this location to keep span lengths below 26 feet.
22						x						x	Bent 22 has little decay in the Timber Piles that can be encased in concrete to prevent any further decay. Move to Bent 21 position.
23			x							x			Bent 23 had deficiencies discovered in the Cap that needs repair, or Bent 24 can move into its place.
24											х		Bent 24 has no deficiencies noted. Either remove or reuse cap at Bent 23.
25	х				x					х			Bent 25 has been tilted out of alignment. The deficiencies discovered in the Mud Sill can be repaired, or Bent 26 can be moved into this location.
26						x					×		Bent 26 has minor decay in the Timber Piles. It can either be removed or reused at Bent 25.

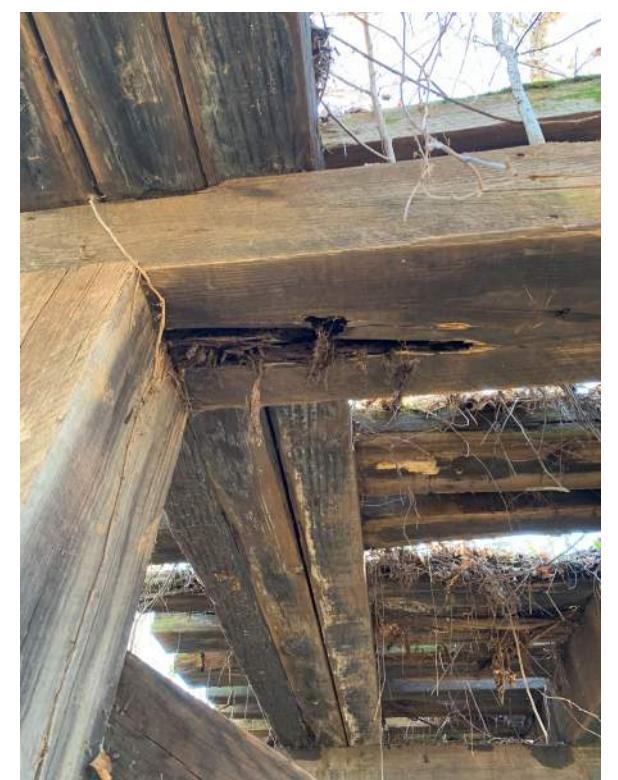
Bent 23 (Cap Decay)

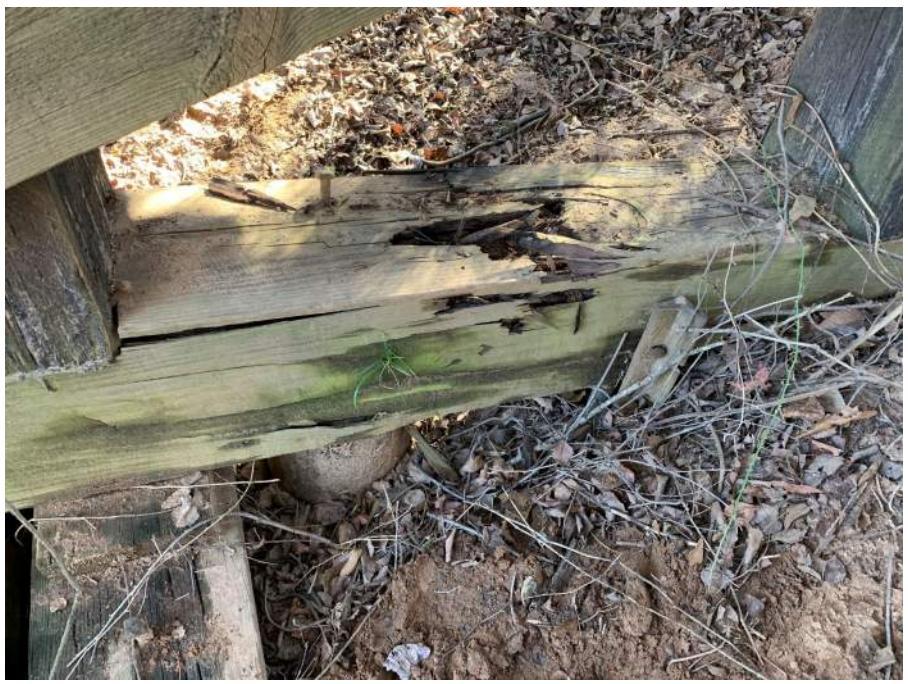
Bent 25 (Mud Sill Decay)

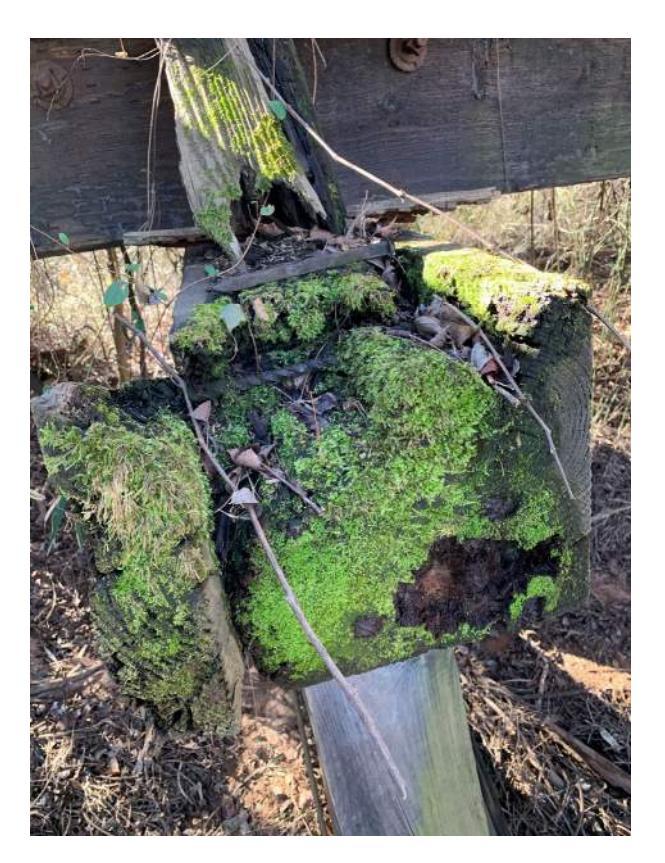
Bent 27 (Cap Decay)

27			х							х			Bent 27 has minor decay in the Cap therefore Bent 27 is a great candidate to remain.
28			x	x		x					x		Bent 28 had deficiencies in the Cap, Timber Frame, and Timber Piles during the inspection leading to the conclusion that Bent 28 should be removed.
29					х					х			Bent 29 had deficiencies in the Mud Sill during the inspection and will need minor repairs.
30											х		Bent 30 has no deficiencies noted and can be resued at Bent 31.
31			x							х			Bent 31 had deficiencies in the Cap that will require repair or Bent 30 can be used in its place.

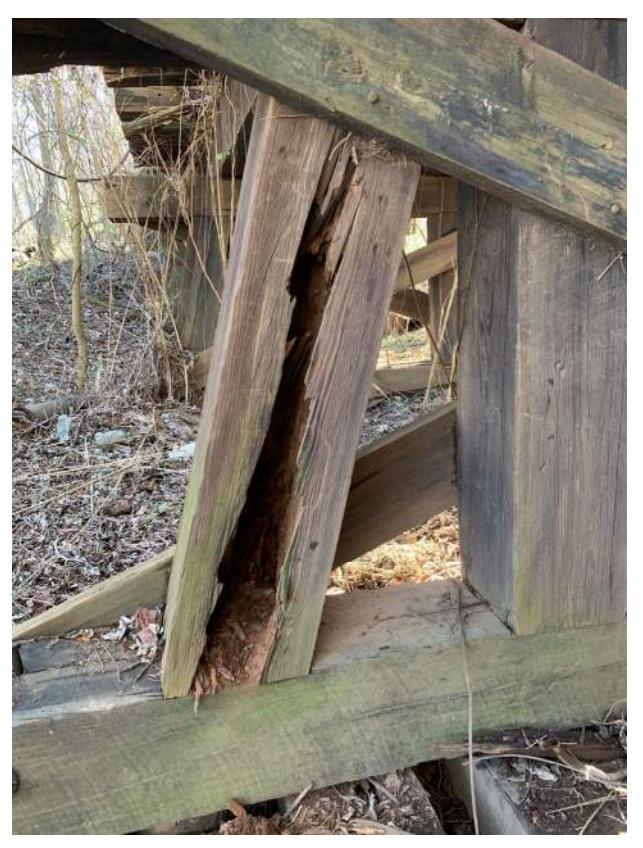
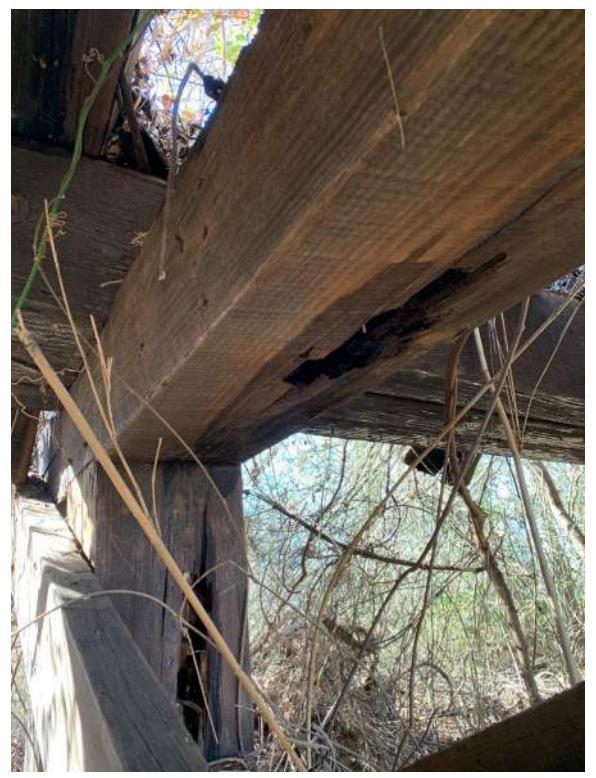
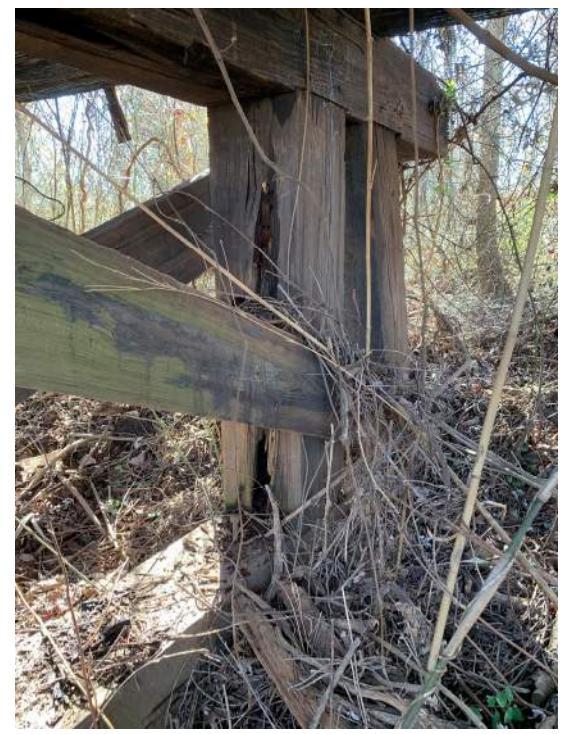
Bent 28 (Timber Frame Decay)

Bent 28 (Cap Decay)

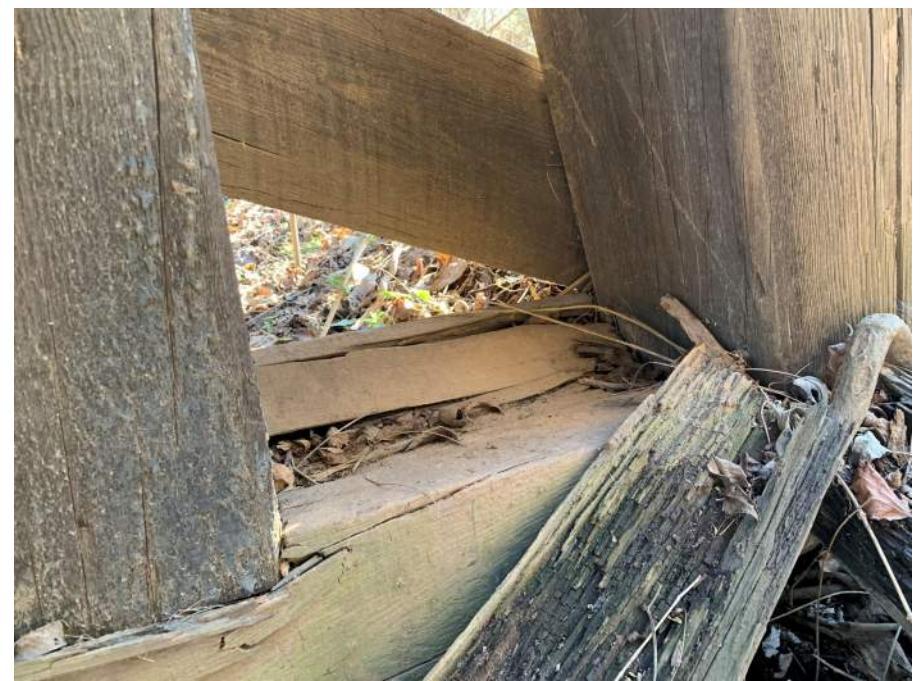
Bent 29 (Mud Sill Decay)

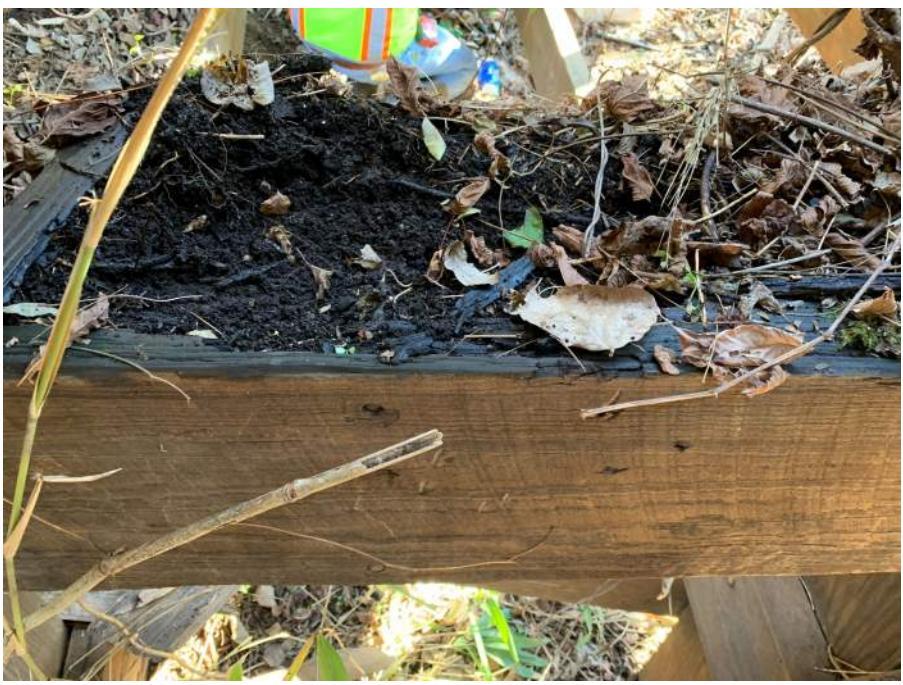
Bent 31 (Cap Decay)

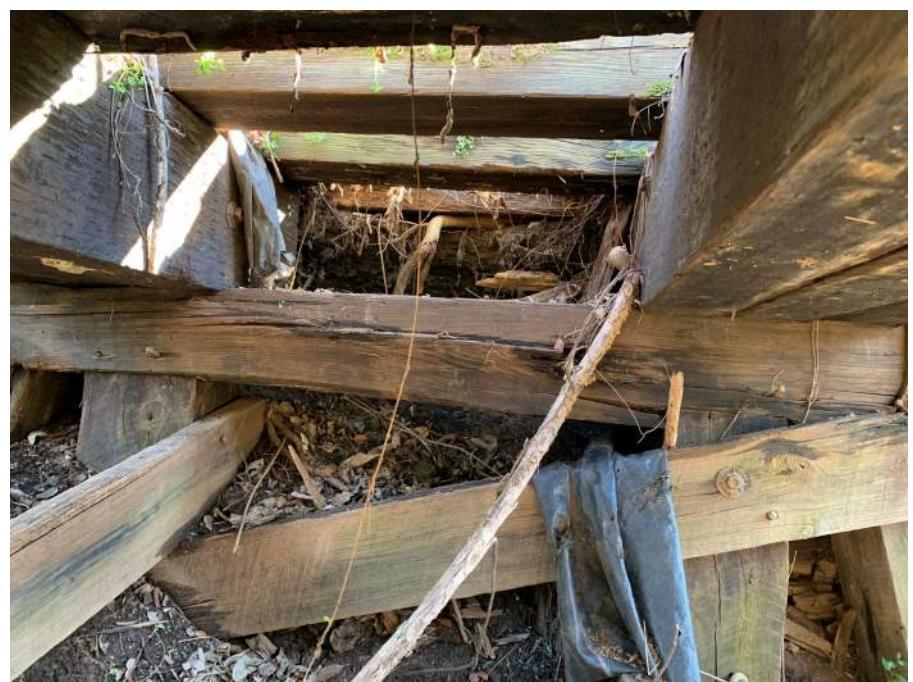
Bent 32 (Cap Decay)

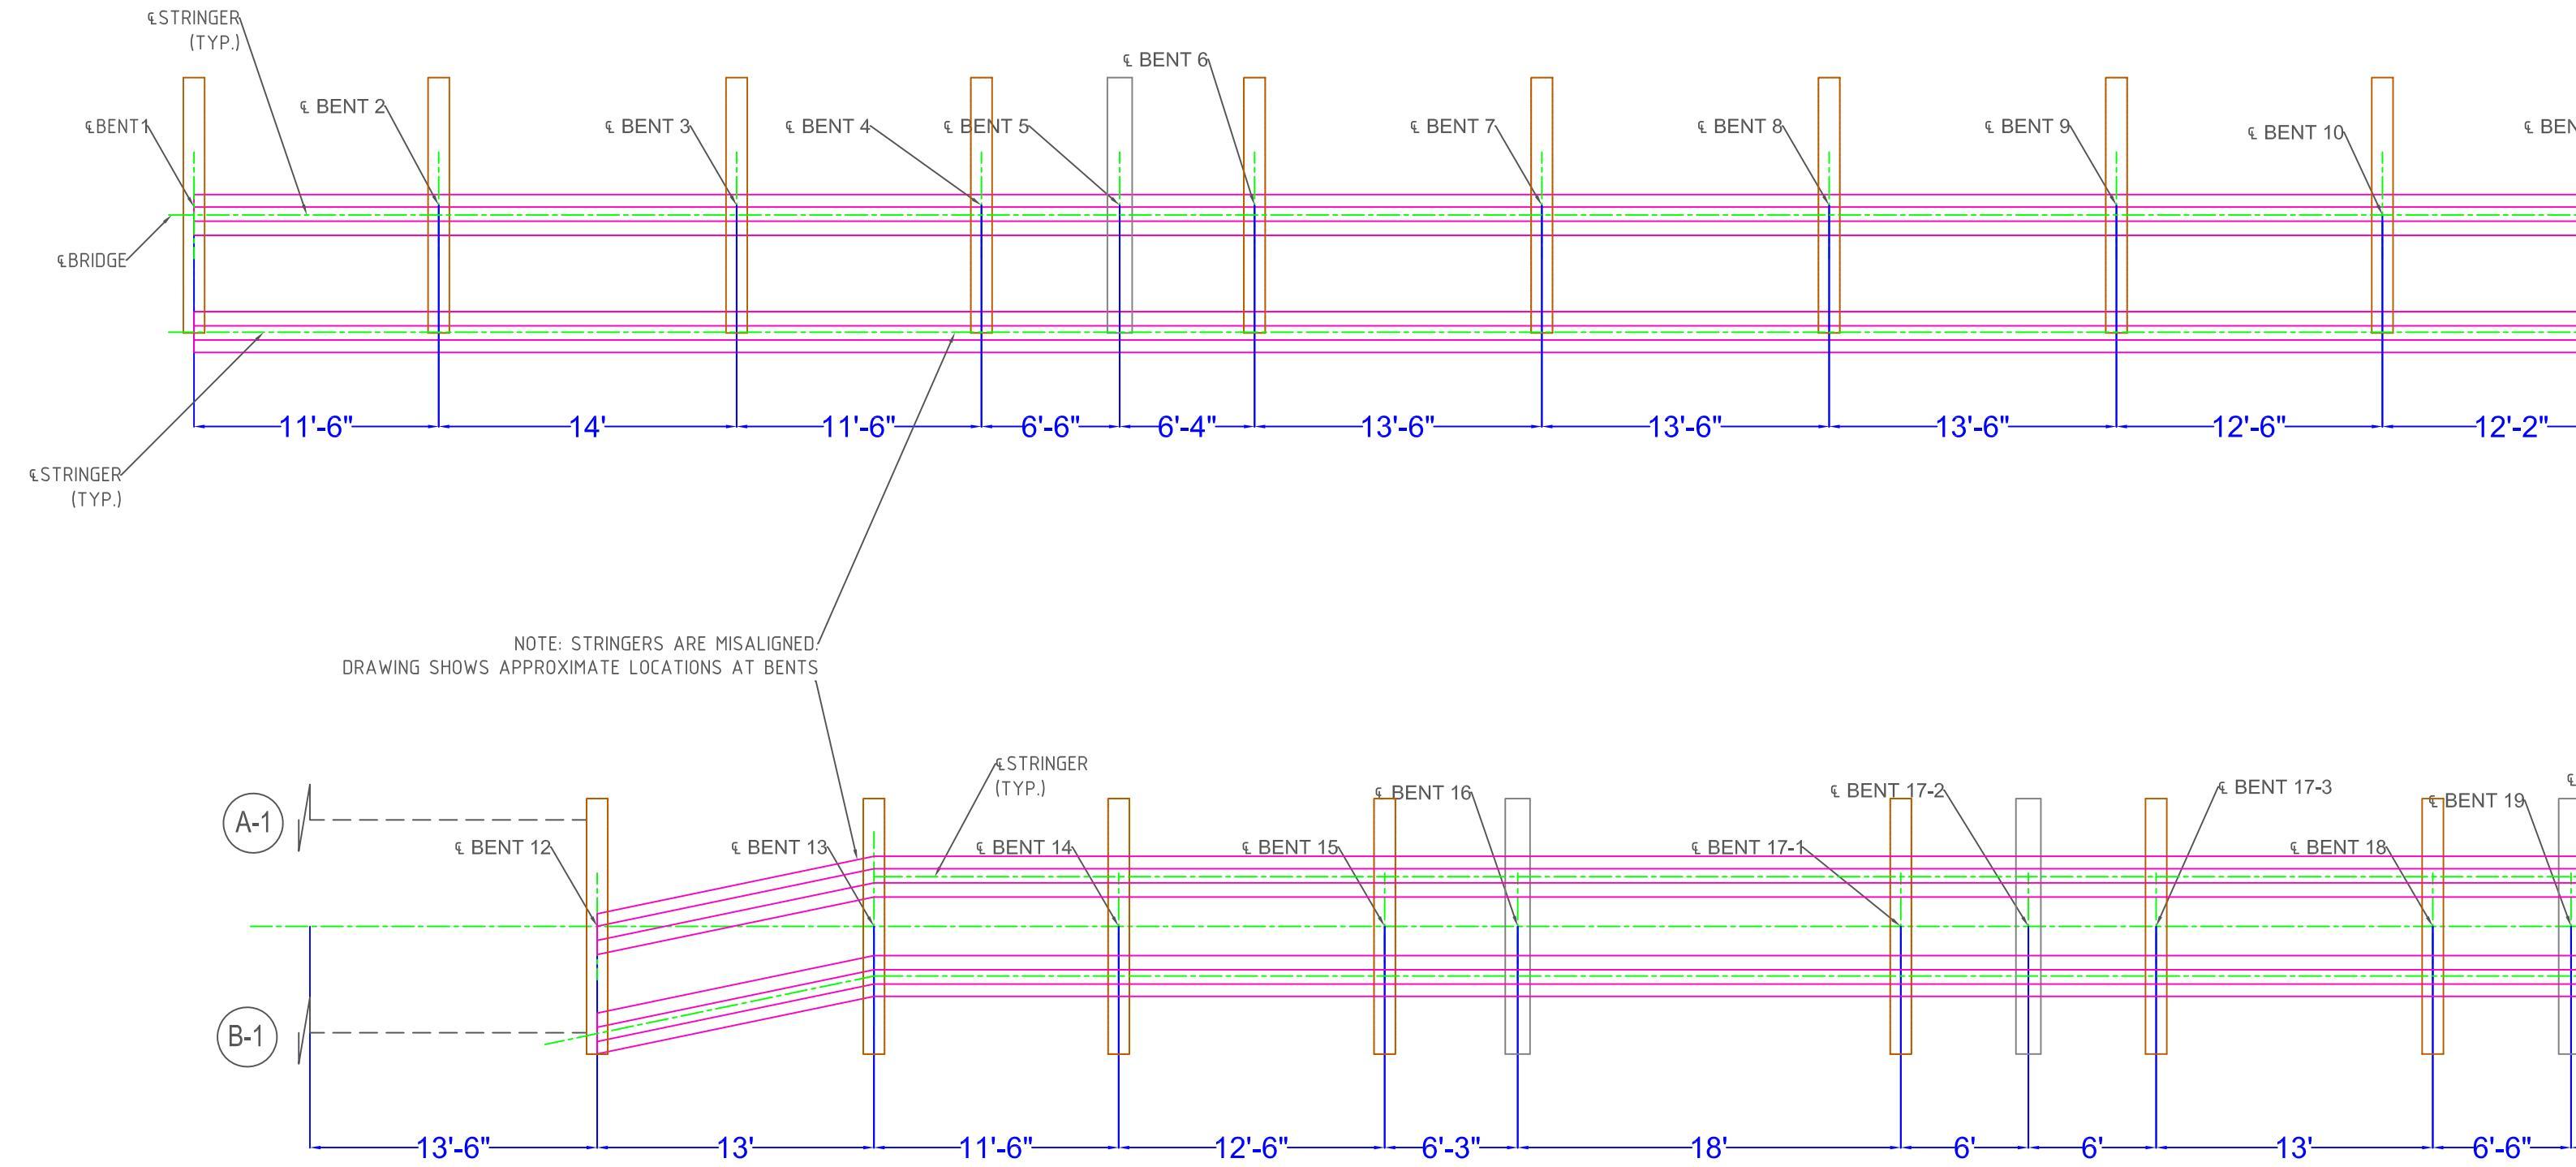
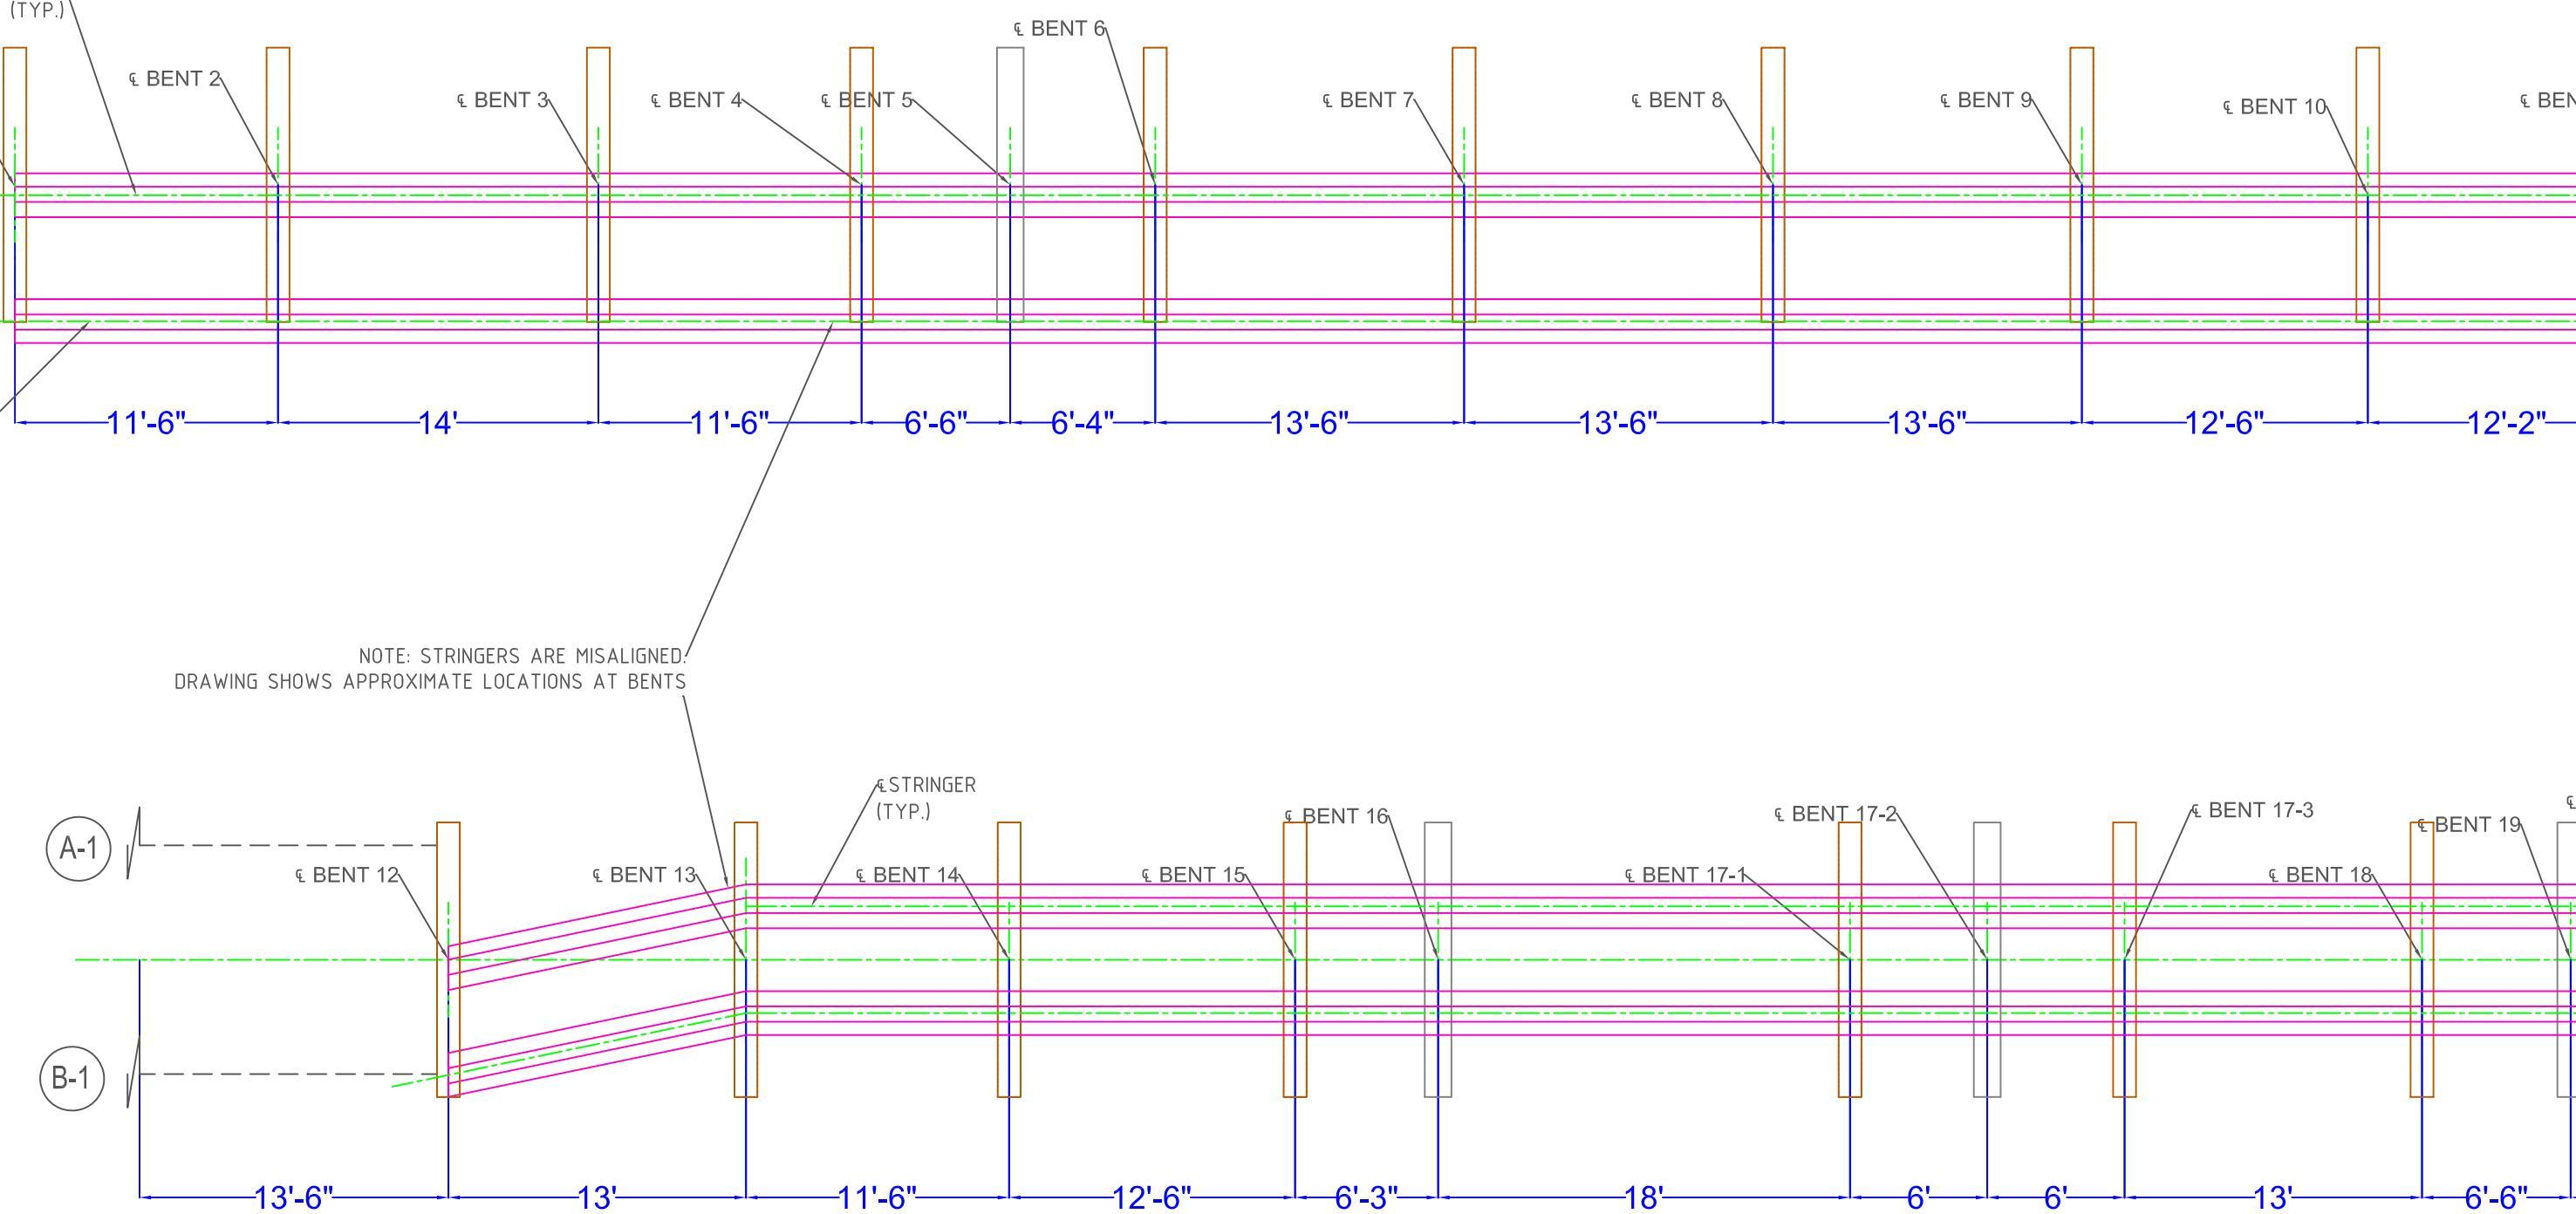
APPENDIX B: EXISTING PLAN VIEW

The existing bridge adjacent to W. Washington Street is a 31-span structure about 380 feet in length. The decking has steel tracks and timber railroad ties, supported by two sets of continuous timber stringers. The abutments and interior bents are mostly timber frames supported on piles with several likely retrofitted concrete caps and steel H-piles. Span
