Request for Proposals (RFP): Pedestrian Bridge to Orange Line Connection

Organization Name: Upstate Greenways and Trails Alliance

UGATA will plan, design, engineer, and permit a trail connectivity project on the Orange Line of the Prisma Health Swamp Rabbit Trail. This project will be called the **Pedestrian Bridge to Orange Line Connection.** This project will involve retrofitting a disused railroad trestle bridge to allow for bicycle and pedestrian use.

SWAMP RABBIT TRAIL: ORANGE LINE REEDY RIVER BRIDGE FEASIBILITY STUDY

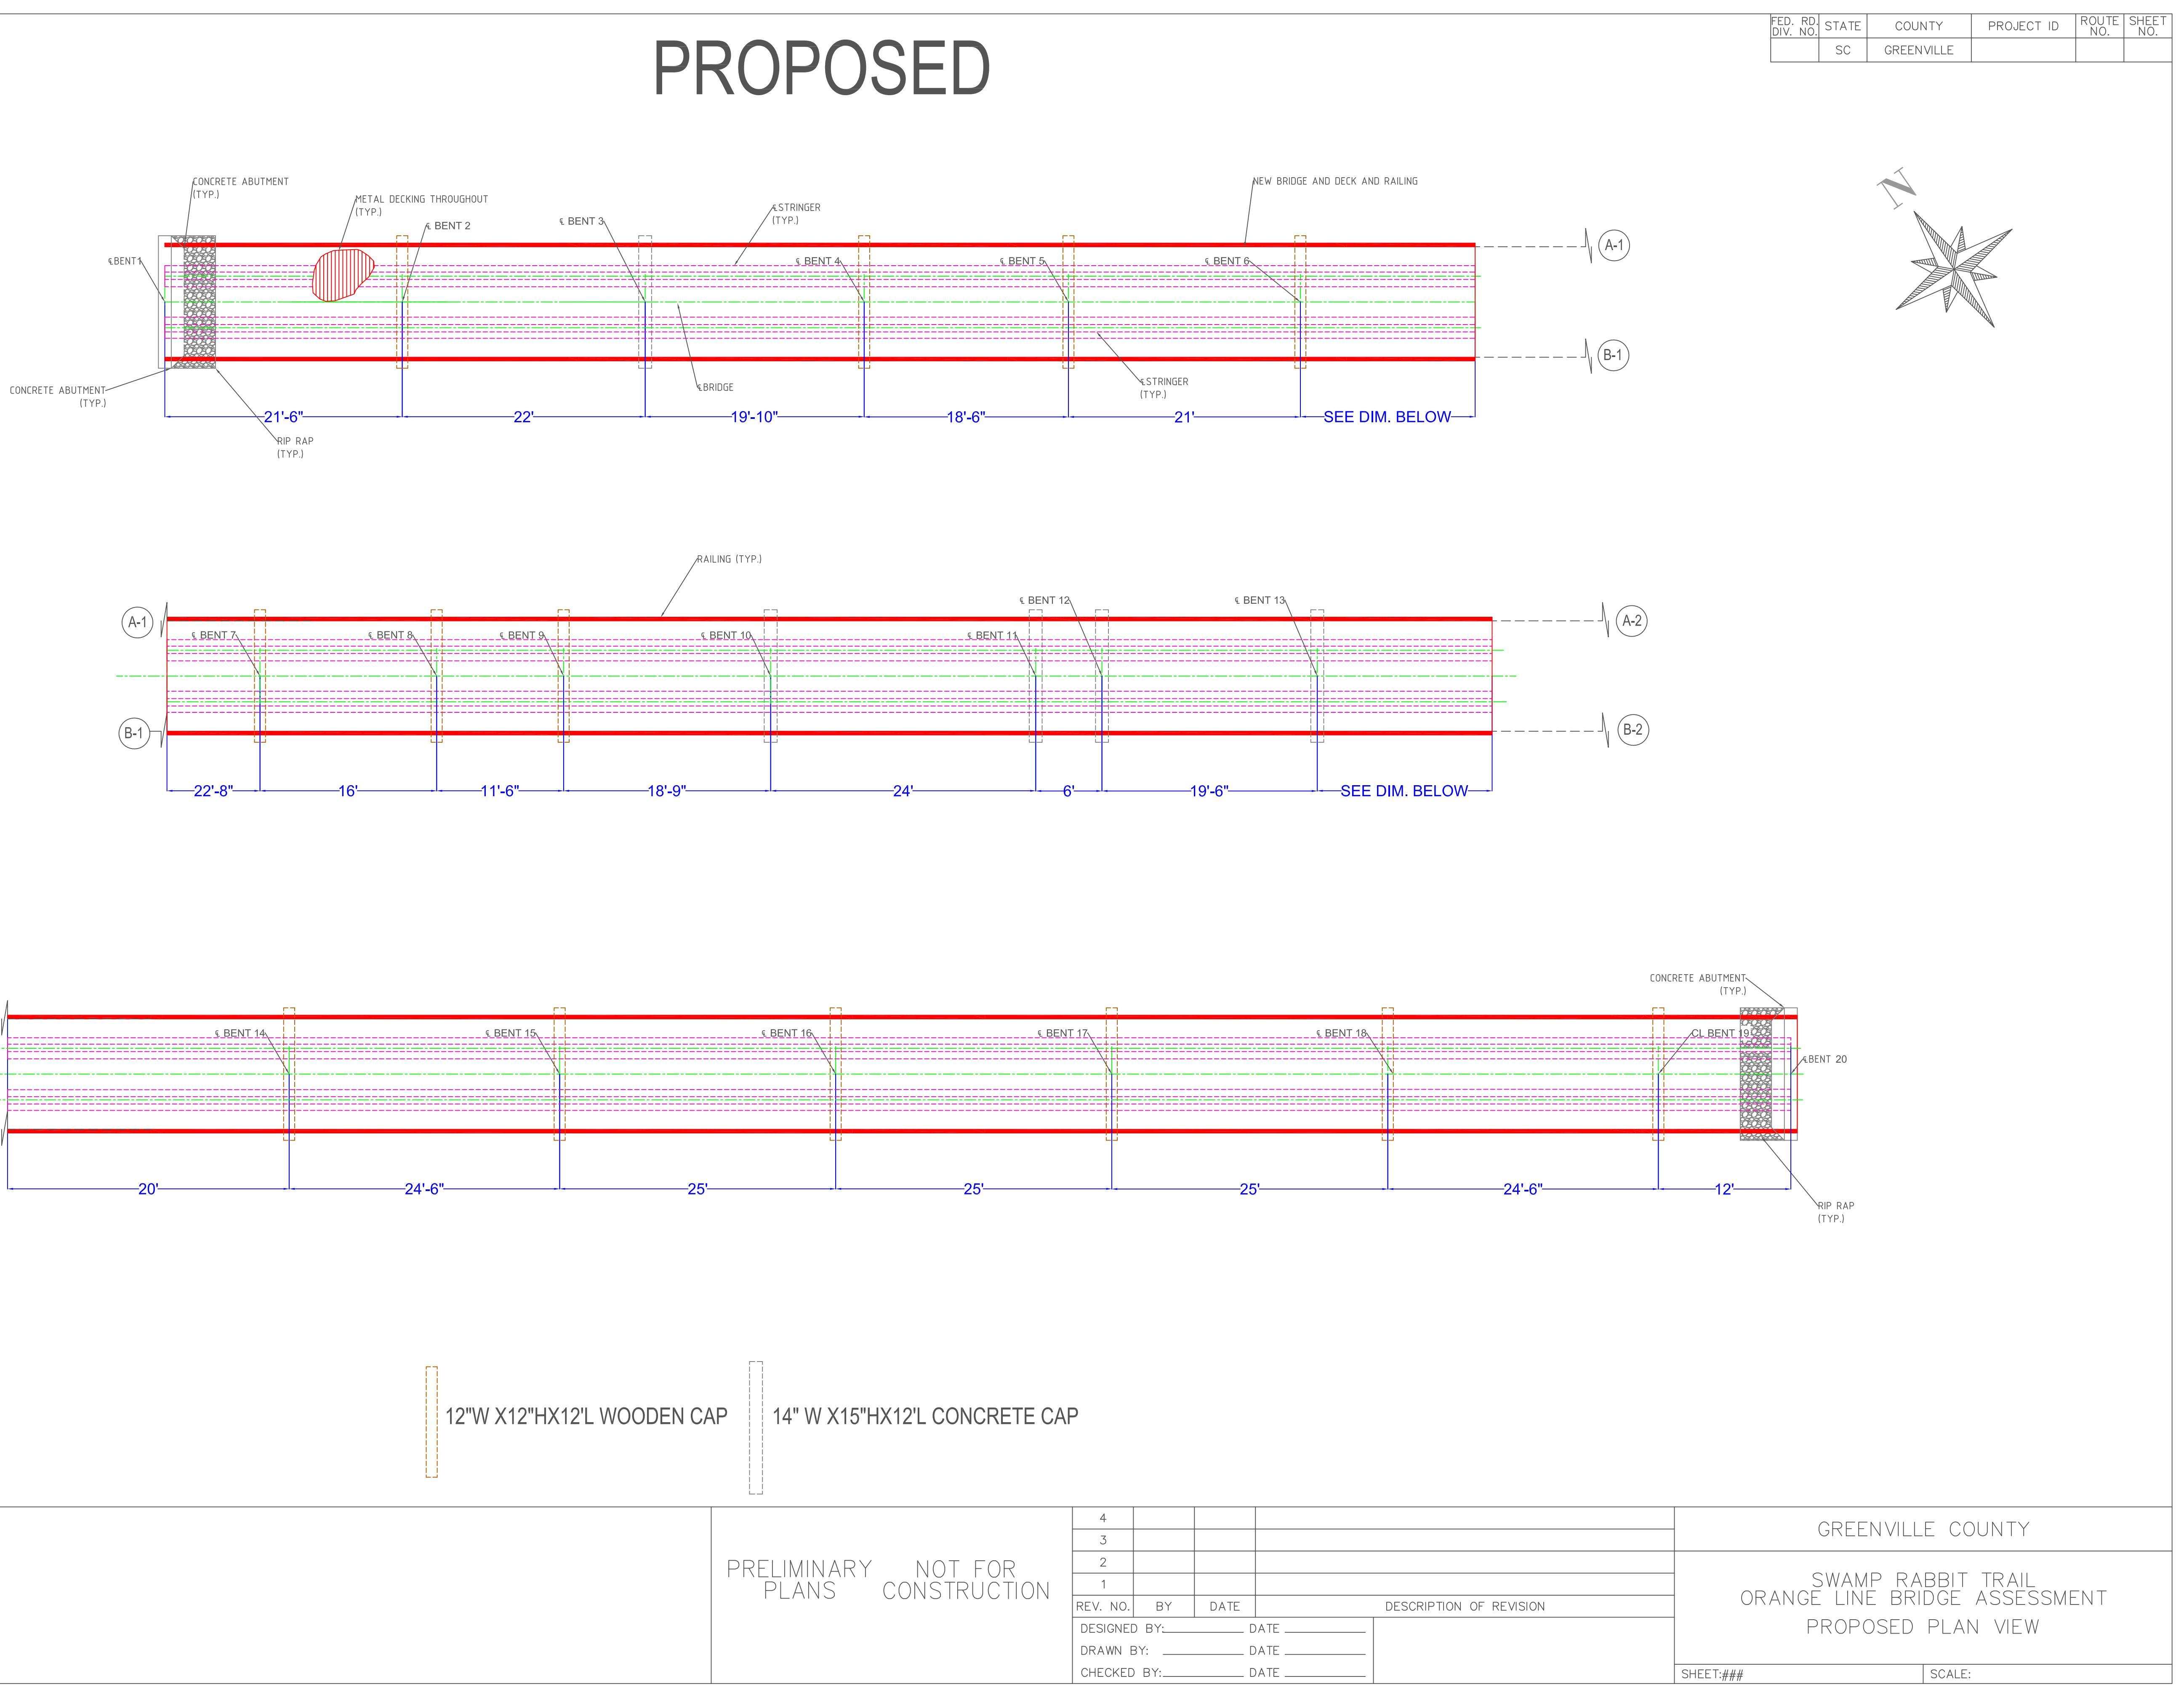
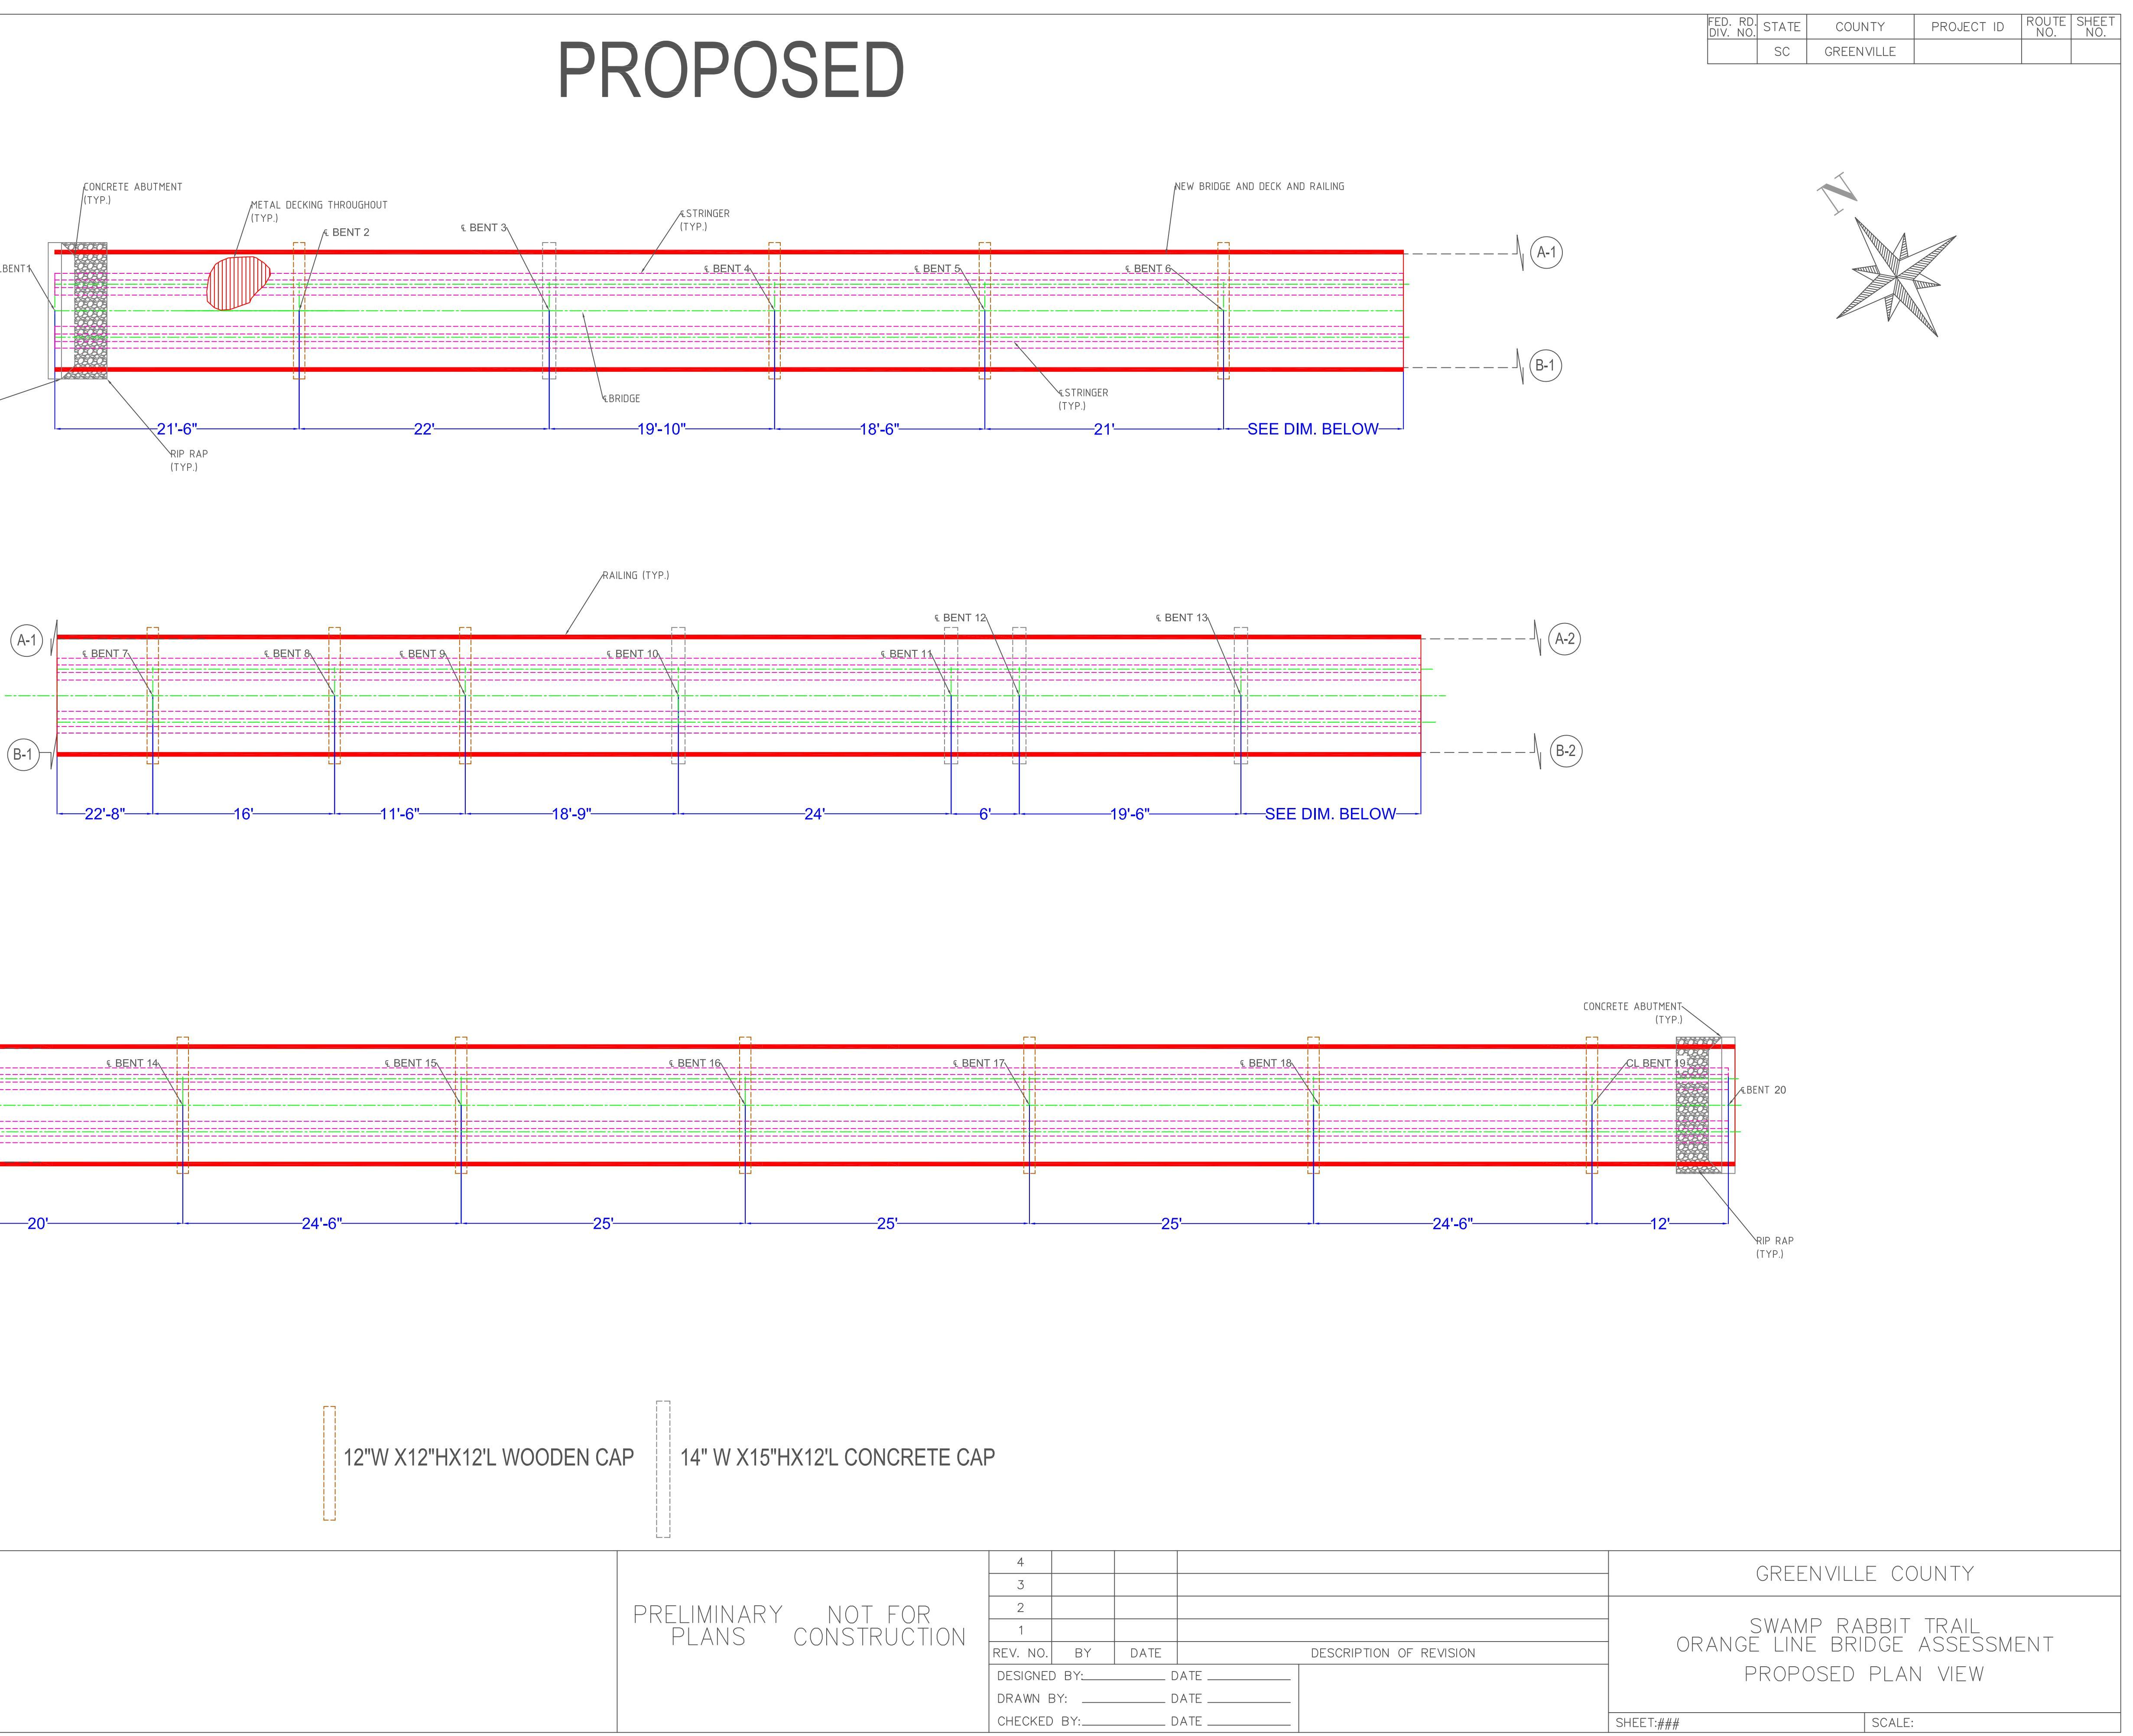
APPENDIX E: PROPOSED PLAN VIEW

It was determined that a maximum span length of 25-feet will provide the required capacity while limiting the deflection to acceptable limits. Based on the condition of each bent and a maximum span length of 25 feet, a conceptual plan was developed to determine which bents will remain in place and which bents will be removed. In a few instances, bents in good condition will be moved to keep the length within the proposed limits. This resulted in the removal of 14 bents.
